RE: Wetland Determination Results: Property at 1861 Hilltop Ln., Bannockburn, IL
PIN 16-19-202-002; Lat/Lon 42.1958299; -87.8721367;

I provide the following results from a wetland delineation conducted at the property referenced above located in the Village of Bannockburn, Lake County, IL (Figure 1). You hired us to investigate the southern portion of the property for any areas meeting the definition of wetlands or waters of the U.S. (WOTUS) and/or Isolated Waters of Lake County (IWLC). Specifically, we investigated the areas that will be used residential improvements (See attached plans provided by the site engineer, Greengard Inc.). I did not find any wetlands in the proposed improvement areas. Note: wetlands may be present on other areas of the site. These include an excavated pond near the driveway and shrub/forested wetlands near the northern property border. These potential wetlands are not in areas that will be disturbed.

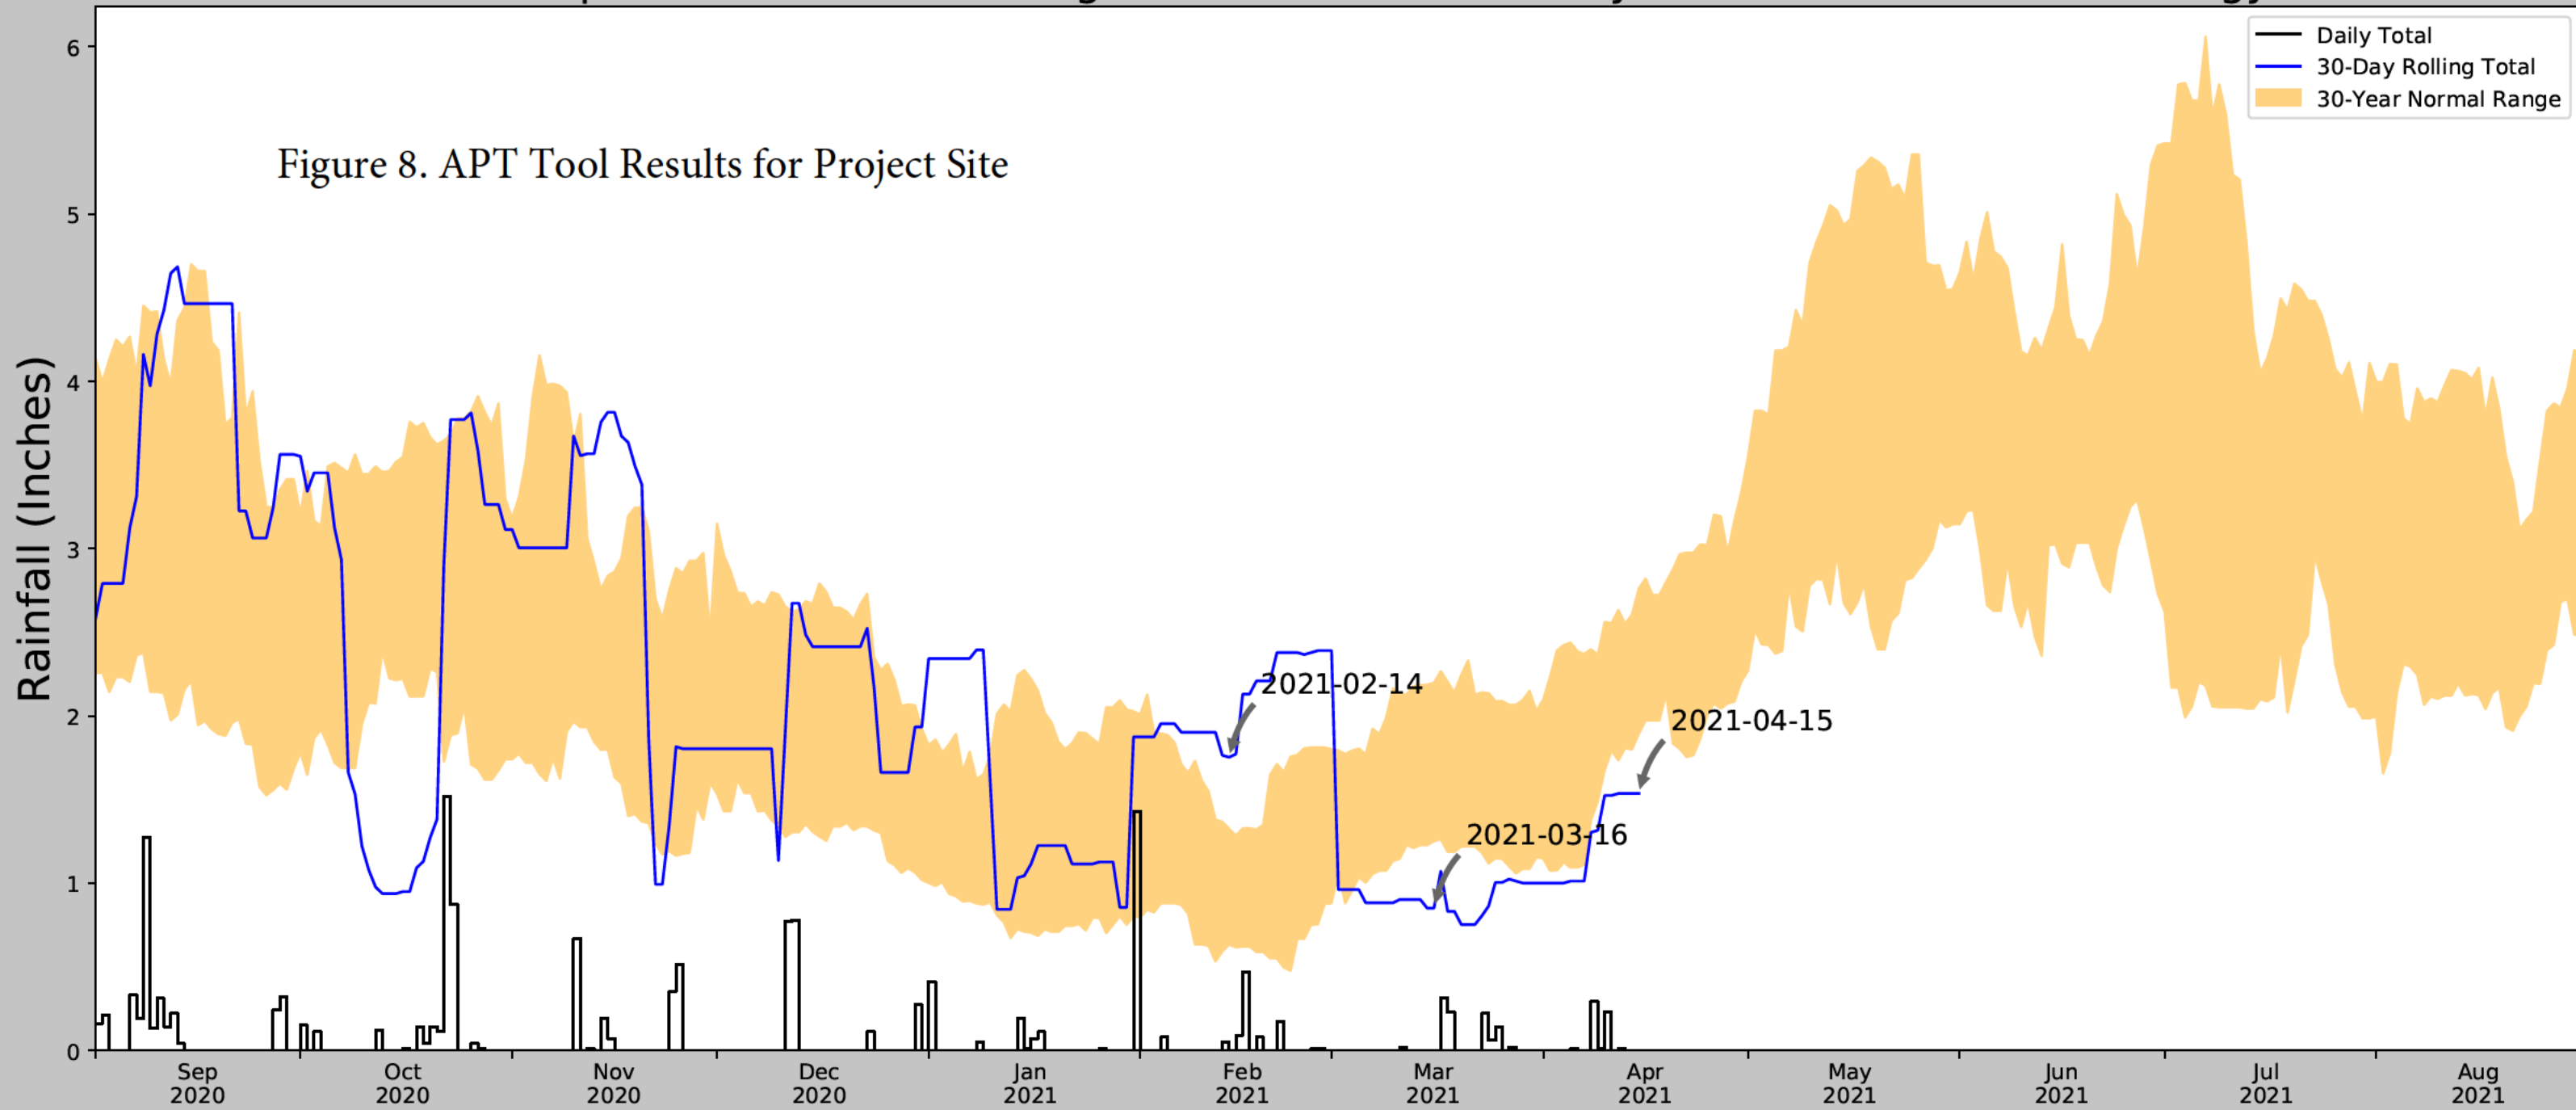
Figure 8. APT Tool Results for Project Site

Antecedent Precipitation vs Normal Range based on NOAA's Daily Global Historical Climatology Network

30 Days Ending	30 th %ile (in)	70 th %ile (in)	Observed (in)	Wetness Condition	Condition Value	Month Weight	Product
2021-04-15	1.894095	2.761417	1.535433	Dry	1	3	3
2021-03-16	1.250787	2.197244	0.850394	Dry	1	2	2
2021-02-14	0.632677	1.324016	1.751969	Wet	3	1	3
Result							Drier than Normal - 8

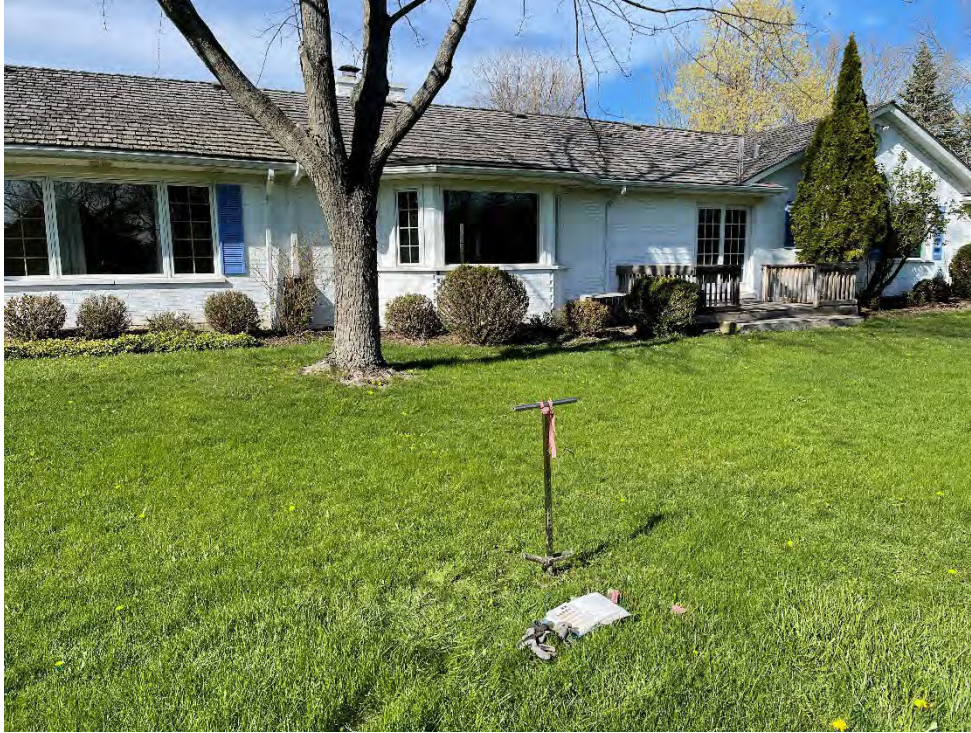
Hydrophytic Vegetation Present? Yes <input type="checkbox"/> No <input checked="" type="checkbox"/> Hydric Soil Present? Yes <input type="checkbox"/> No <input checked="" type="checkbox"/> Wetland Hydrology Present? Yes <input type="checkbox"/> No <input checked="" type="checkbox"/>	Is the Sampled Area within a Wetland? Yes <input type="checkbox"/> No <input checked="" type="checkbox"/>
Remarks: Mowed turf grass area near residential structure.

1. Data point 1UPL (Upland) showing turfgrass and existing residence facing northeast.

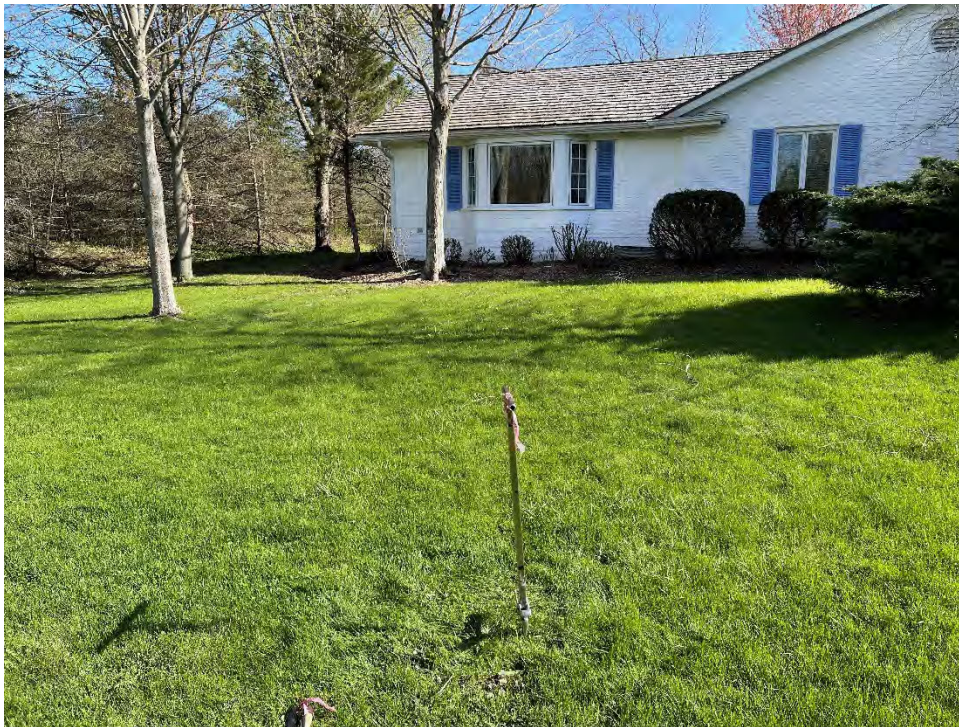
Hydrophytic Vegetation Present? Yes <input type="checkbox"/> No <input checked="" type="checkbox"/> Hydric Soil Present? Yes <input type="checkbox"/> No <input checked="" type="checkbox"/> Wetland Hydrology Present? Yes <input type="checkbox"/> No <input checked="" type="checkbox"/>	Is the Sampled Area within a Wetland? Yes <input type="checkbox"/> No <input checked="" type="checkbox"/>
Remarks: Mowed turf grass area near residential structure.

2. Data point 2UPL (Upland) facing south viewing front (north side) of residence.

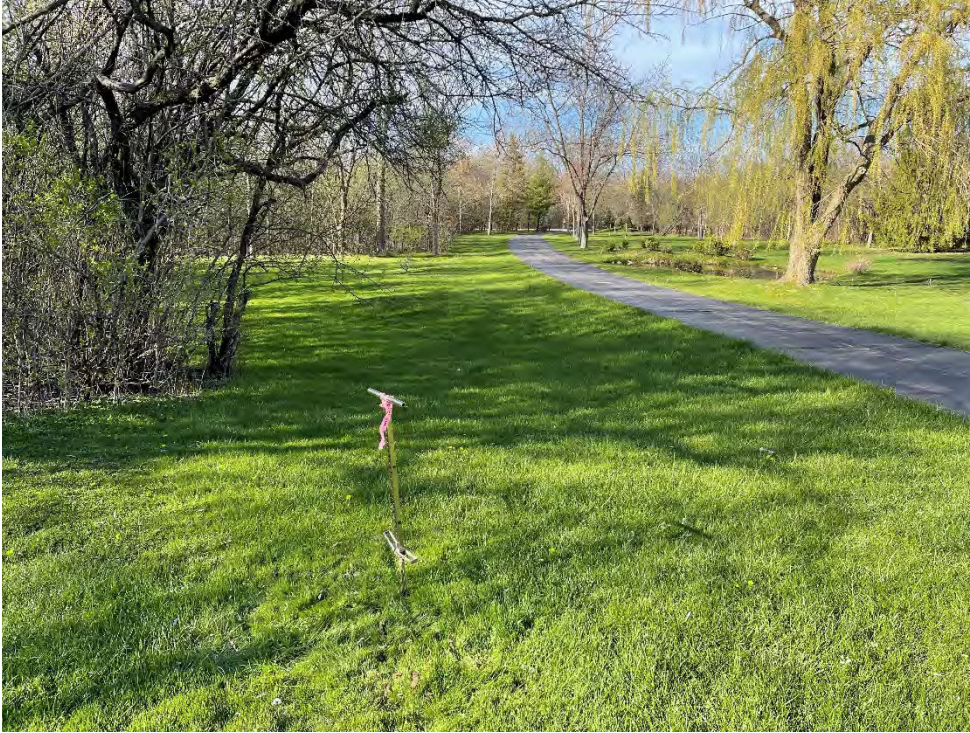
Hydrophytic Vegetation Present? Yes <input checked="" type="checkbox"/> No _____ Hydric Soil Present? Yes _____ No <input checked="" type="checkbox"/> Wetland Hydrology Present? Yes _____ No <input checked="" type="checkbox"/>	Is the Sampled Area within a Wetland? Yes _____ No <input checked="" type="checkbox"/>
Remarks: Mowed turf grass near driveway.

3. Data point 3UPL (Upland) facing north with residential driveway to the right (east).

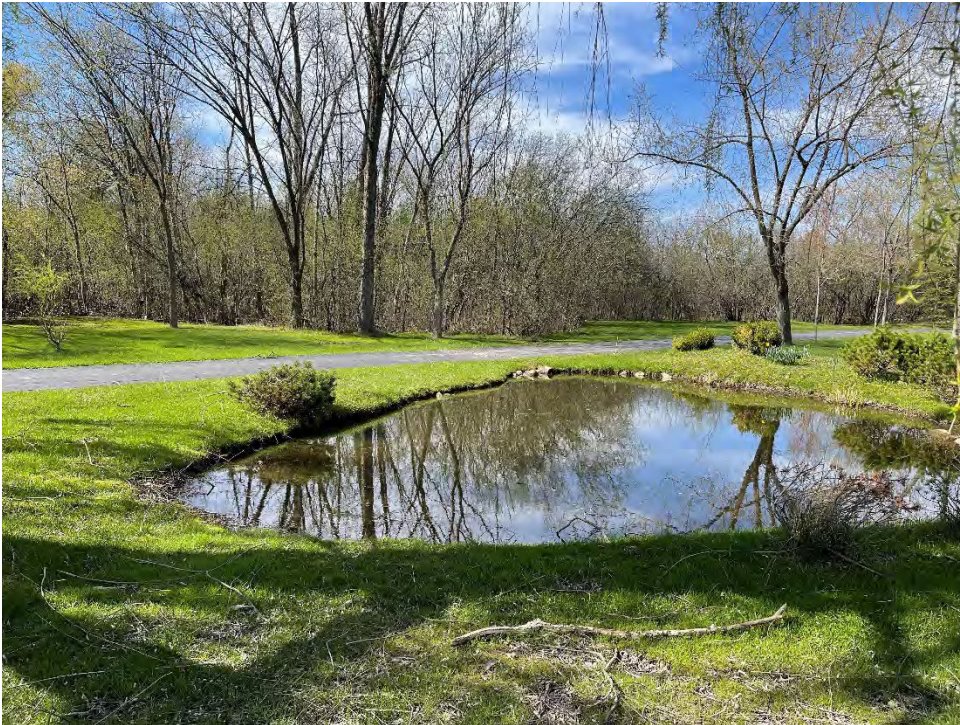
The 3.78-acre residential property contains a one single-story structure, one small shed near west side of the driveway, and manicured turf grass and landscaping for the front, rear, and side yards. A small pond, presumably excavated, exists in the central portion of the site, and contains a 12-inch CMP culvert under the driveway. Lake County GIS indicates that the residence was built circa 1950-60 as it is first shown on the 1961 Lake County aerial photograph. The residence was one of the earlier structures accessing Hilltop Lane. At that time, farmland adjoined the eastern property boundary and pastureland or grassland appears present to the north and west of the site. Infill lots with development of other residential structures occurred shortly thereafter in the late 1970s and early 1980s. Other than small landscaping improvements and possible structure improvement (addition) between 1993 and 1997, the site appears unchanged since the original construction date. The site is in the NE $\frac{1}{4}$ of Section 19, Township 43N, Range 12E, of West Deerfield Township

4. Pond (presumably excavated) with landscaping and culvert facing northwest.

We did not investigate the area near the excavated pond or shrub/sapling wooded area located in the northwest property boundary or along the Thornapple Lane as these were not areas near grading or proposed structures. However, we caution that these areas may contain wetlands and need to be further investigated if work is proposed near them. Also, a sump pump discharge at the southern portion of the residence (near a wooden deck) is causing a ponded condition as shown on Photograph 5. We recommend providing positive drainage away from the house for the sump pump discharge.

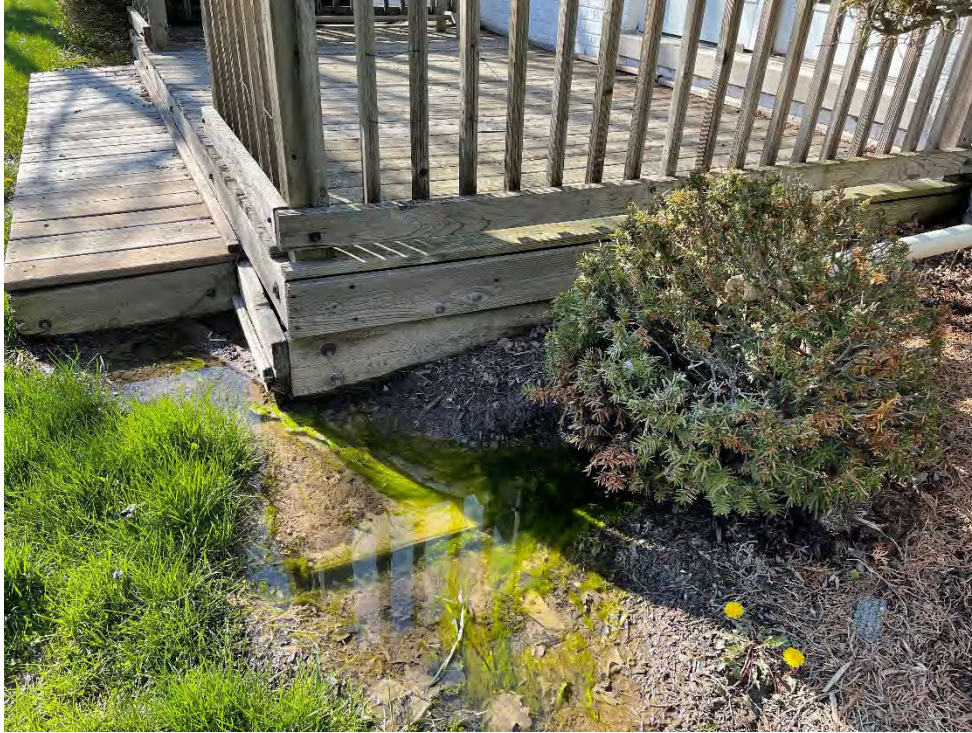
5. Sump pump outlet showing ponded conditions near deck on south side of residence.

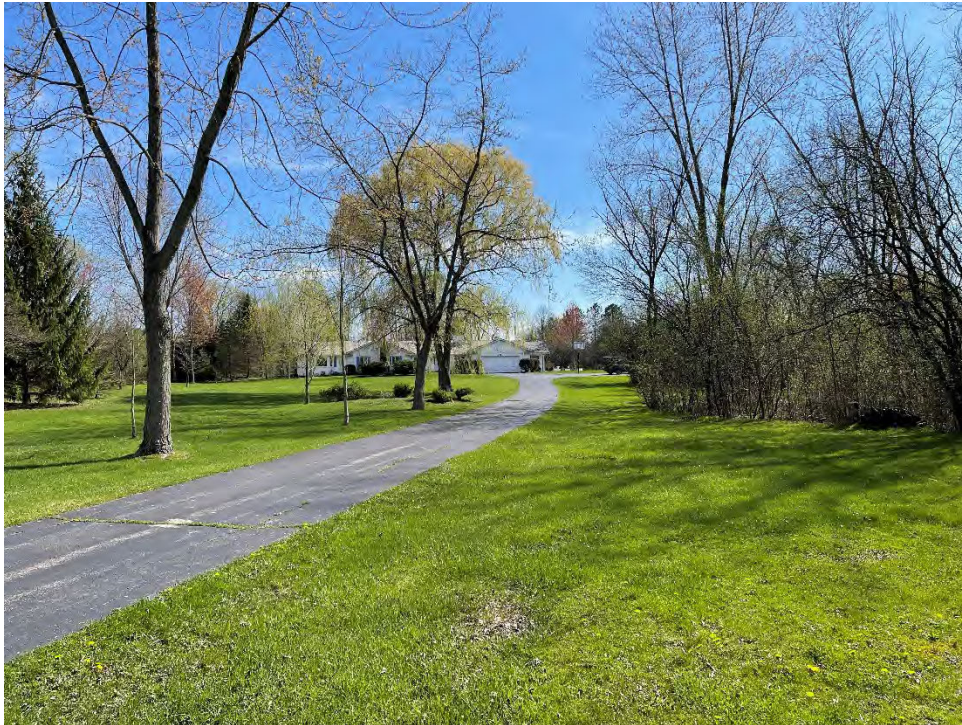
6. View of residence, yard, driveway, and landscaping facing south from the northern property boundary.
